Following the full survey and documentation of all existing conditions at Building 18 in Magnusen Park for the new Outdoors For All facility, I have prepared the following report. There are two main window types/vintages present. The ground floor and a couple of the second-floor windows are of an older and more traditional style of steel window with the predominant windows at the second level appearing to be newer and in not as good condition.

Outdoors for All Window Remediation Summary and Recommendations

BUILDING 18 WINDOW SURVEY

**Rafn- BLDG#18
WINDOW SURVEY**

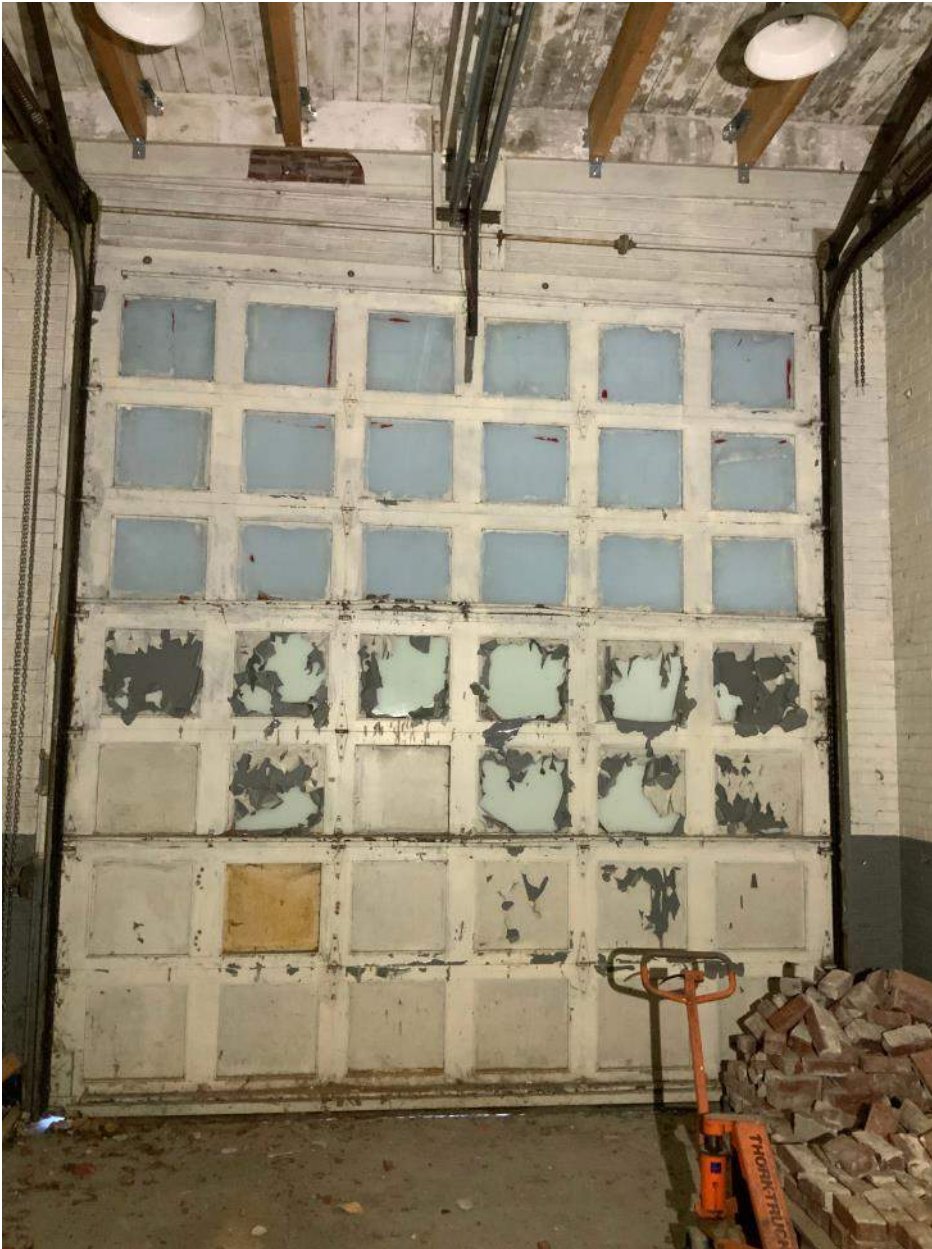
DESCRIPTION	
WINDOW LOCATION	G-Door
WINDOW CONDITION	Typical/ Fair
HARDWARE	
GLASS	Obscure
WEIGHTS	
TRIM	
OSB DIMENSIONS	
CRITICAL DIMENSIONS	156"X169"

Overall the Door is a candidate for restoration.

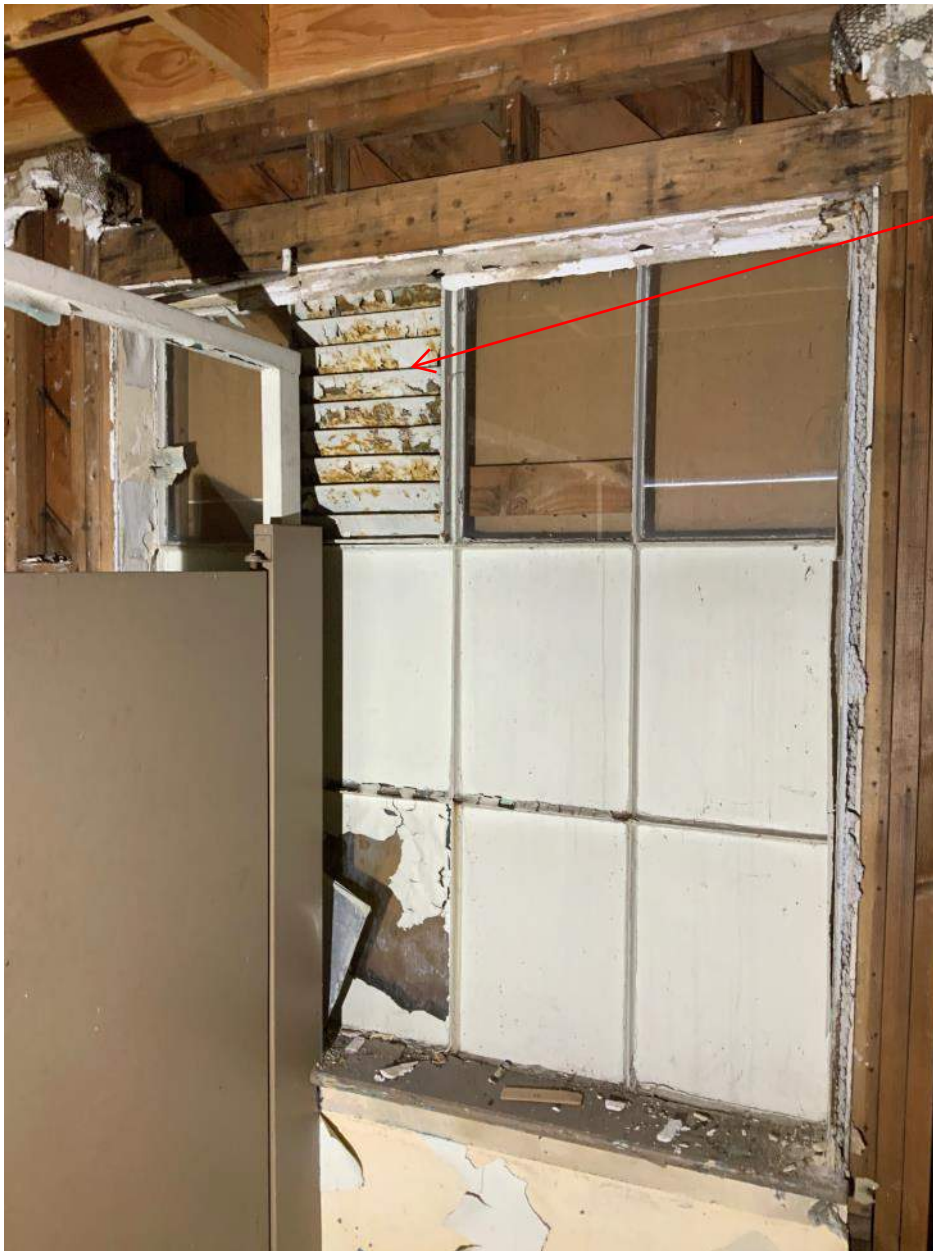
DESCRIPTION	Awning
WINDOW LOCATION	E-2-1
WINDOW CONDITION	Typical/Fair
HARDWARE	None
GLASS	1/8" Clear/ Obscure Painted Glazing
CRITICAL DIMENSIONS	58"X62"

Louver in Sash

Mechanical Louver

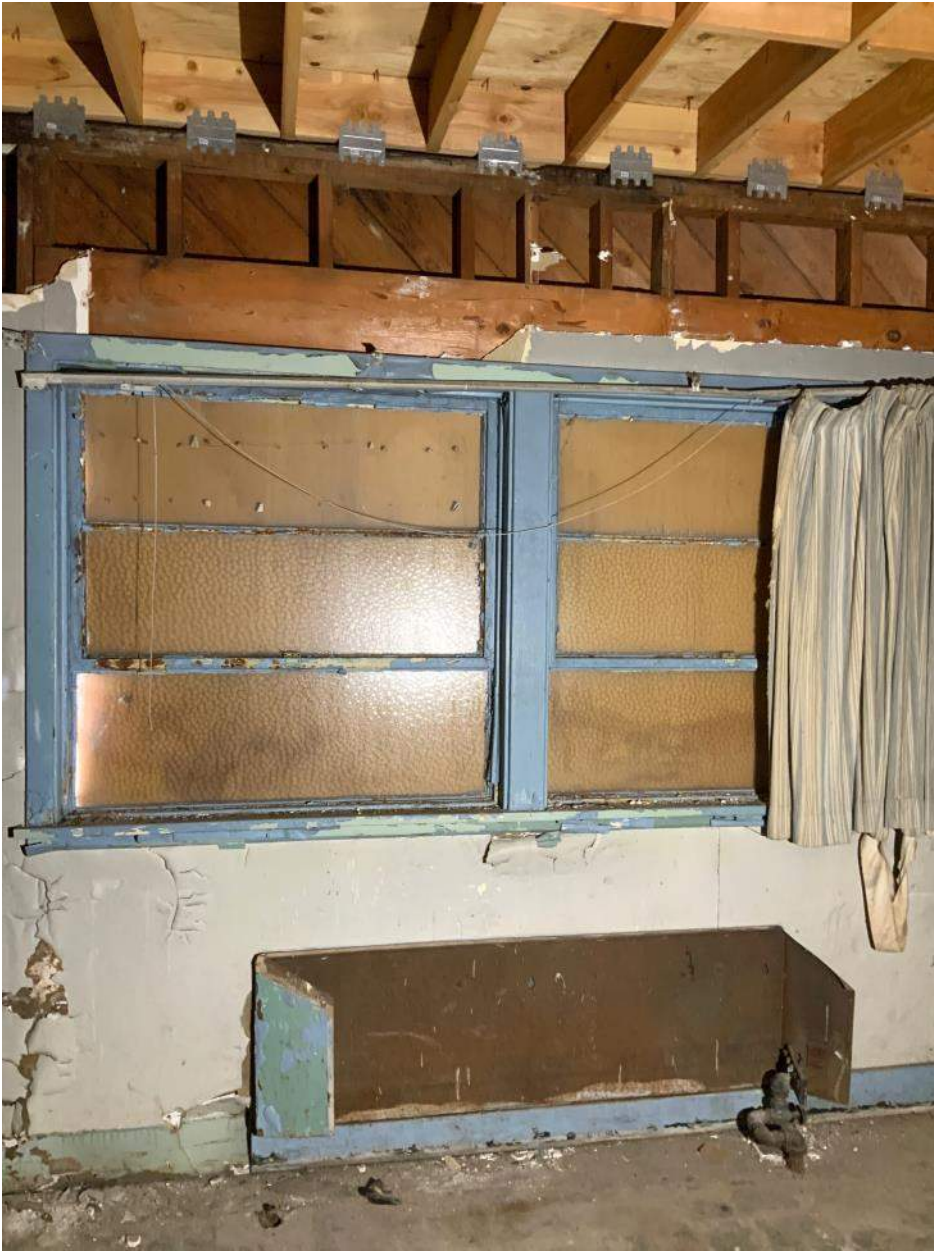
DESCRIPTION	Awning
WINDOW LOCATION	S-2-5 & S-2-6
WINDOW CONDITION	Poor
HARDWARE	Missing/ Broken
GLASS	1/8" Clear/ Historic Obscure Glass
CRITICAL DIMENSIONS	49"X50" x2

Obscure 2 bottom rows/ Surface Rust and Pitting Occurring

Heavy rust and pitting
occurring at horizontal
meeting rail

Missing/Broken
Hardware and heavily
rusted

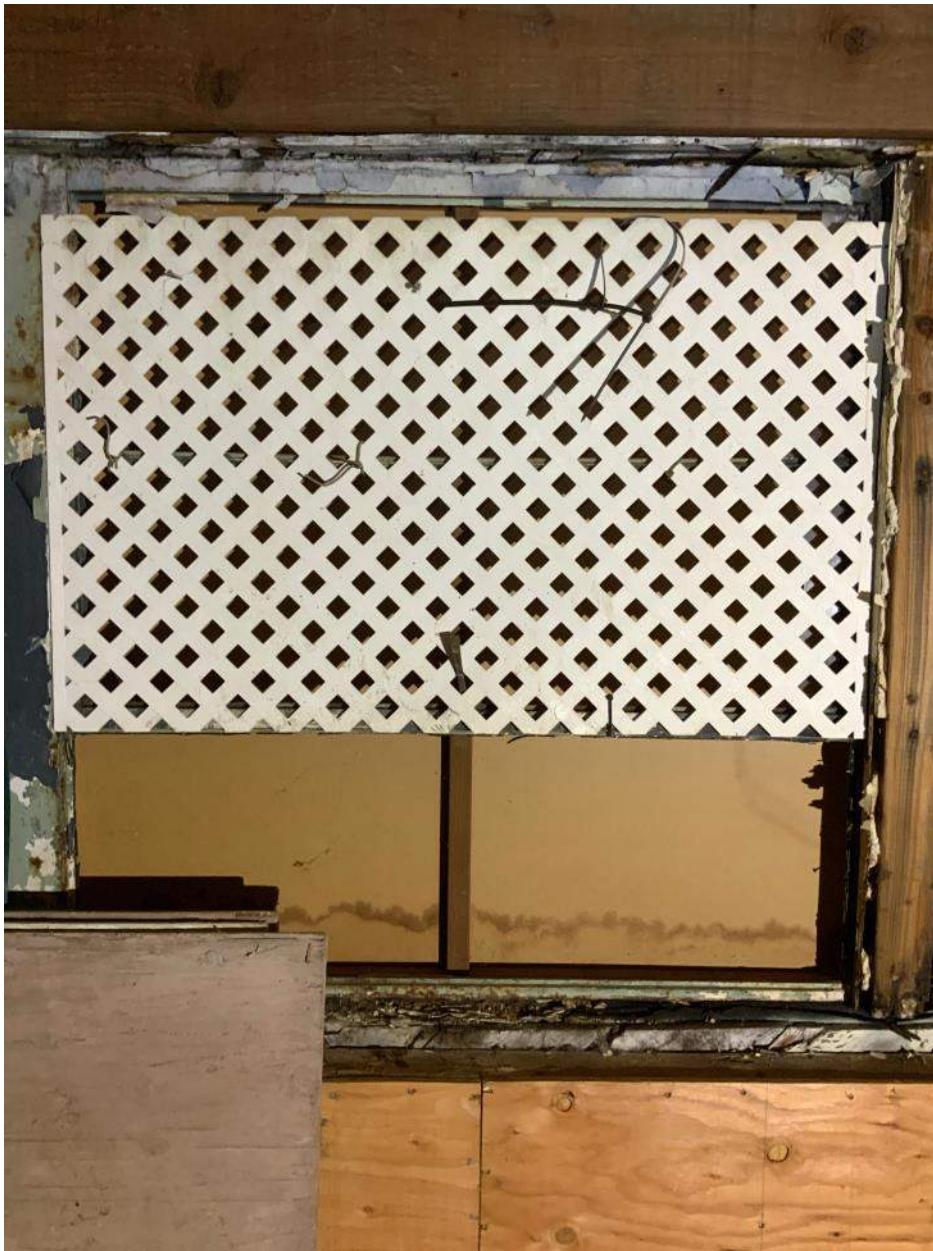
DESCRIPTION	Awning
WINDOW LOCATION	N-2-2
WINDOW CONDITION	Poor
HARDWARE	Missing/Broken
GLASS	1/8" Clear
CRITICAL DIMENSIONS	49"X50"

Center Mullion Cap is
missing

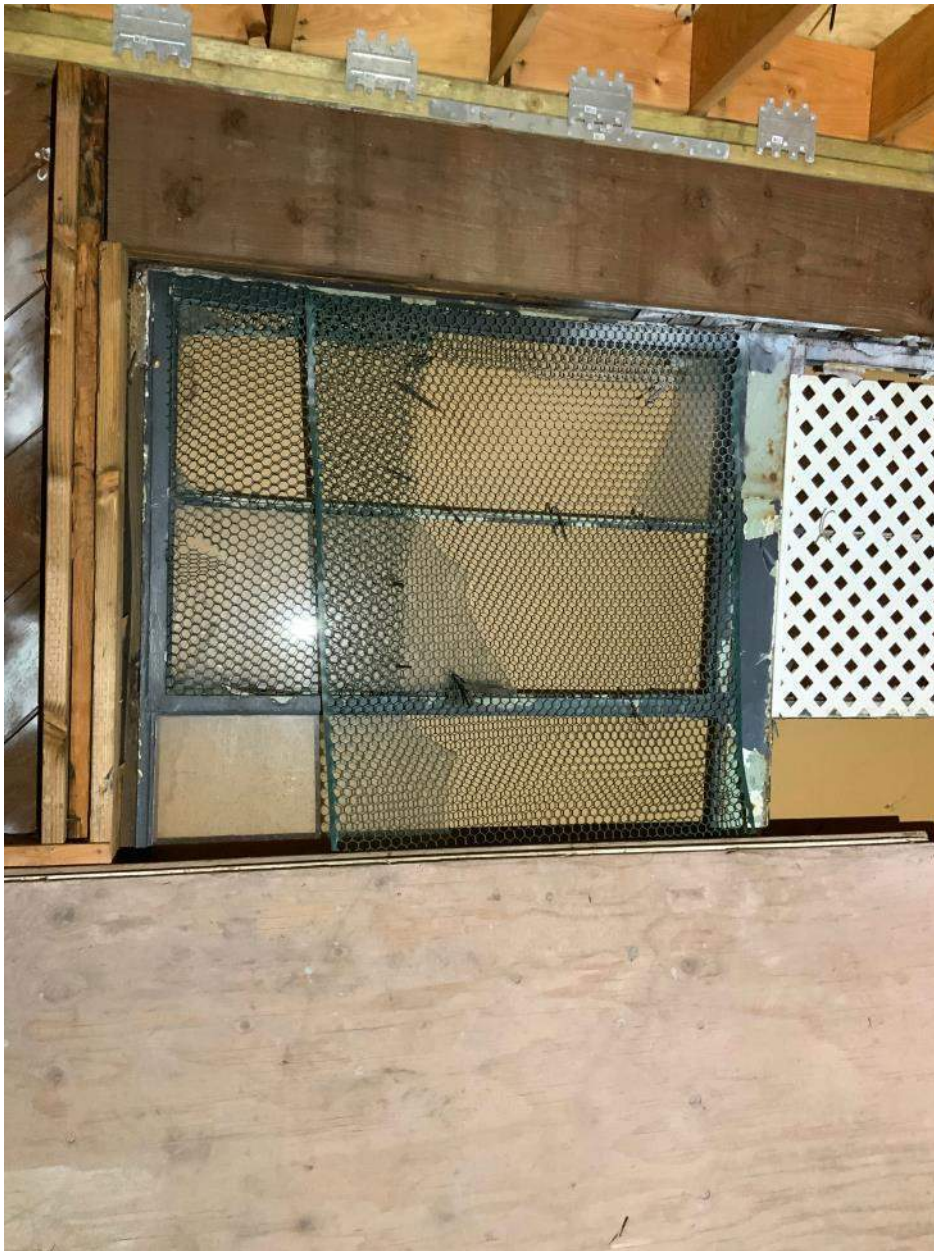
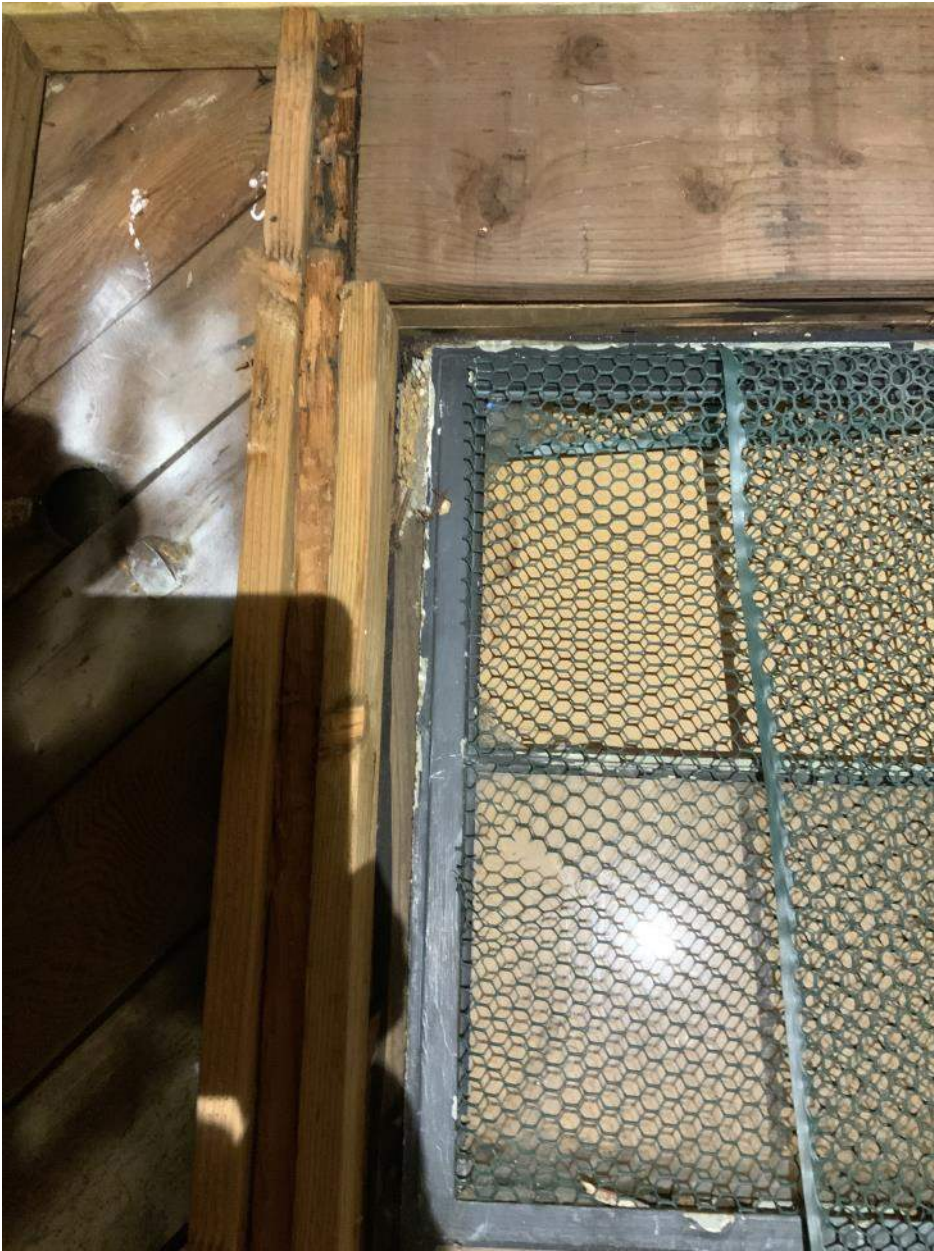
DESCRIPTION	Awning
WINDOW LOCATION	N-2-3
WINDOW CONDITION	Typical/Fair
HARDWARE	Missing/Broken
GLASS	1/8" Clear
CRITICAL DIMENSIONS	49"X50"

Deterioration occurring
at head of jamb

Rust and pitting
occurring at center
mullion

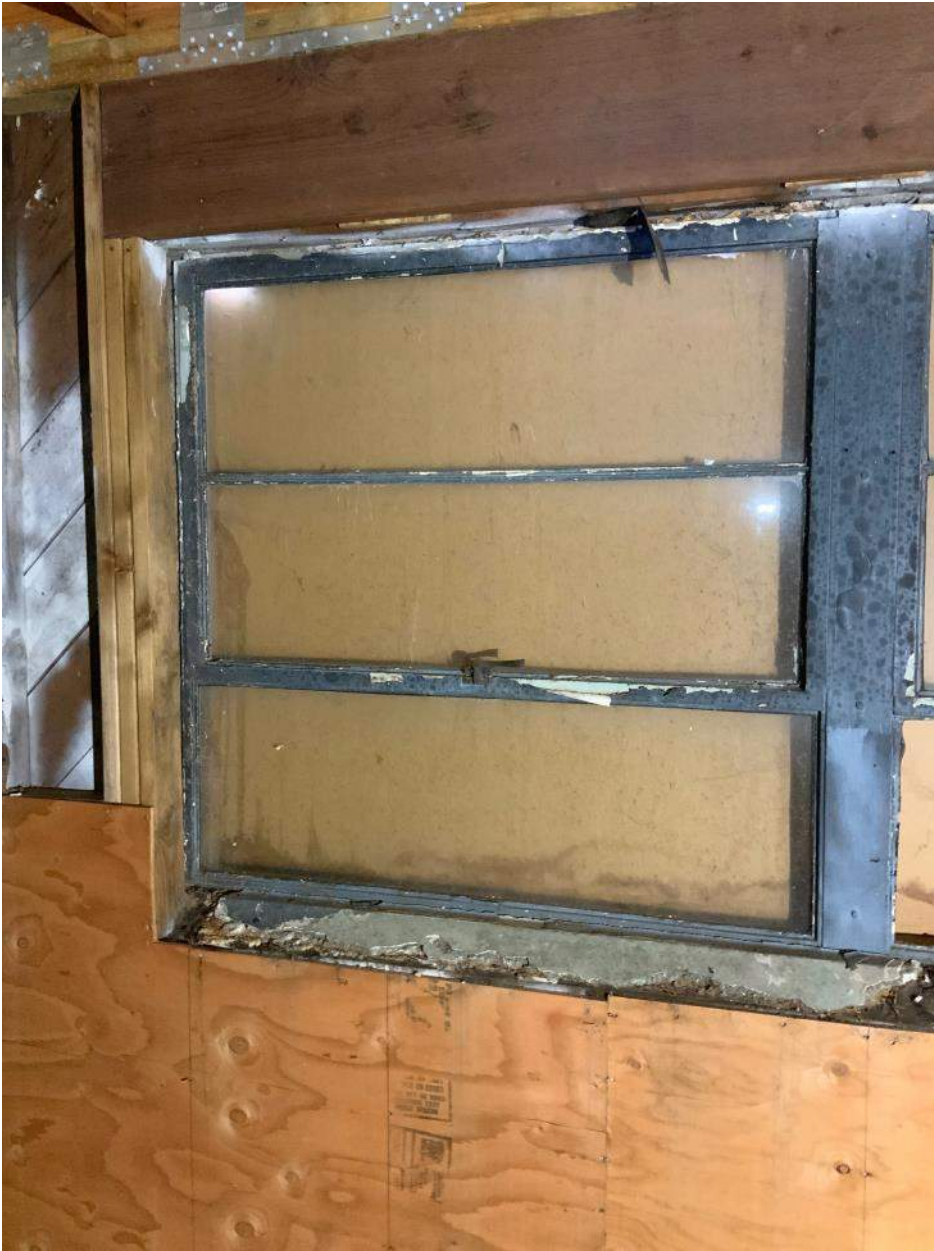
DESCRIPTION	Awning
WINDOW LOCATION	N-2-6
WINDOW CONDITION	Typical/Fair
HARDWARE	Casement lock/ 2 Hinges
GLASS	1/8" Clear
CRITICAL DIMENSIONS	49"X50"

Exterior glazing

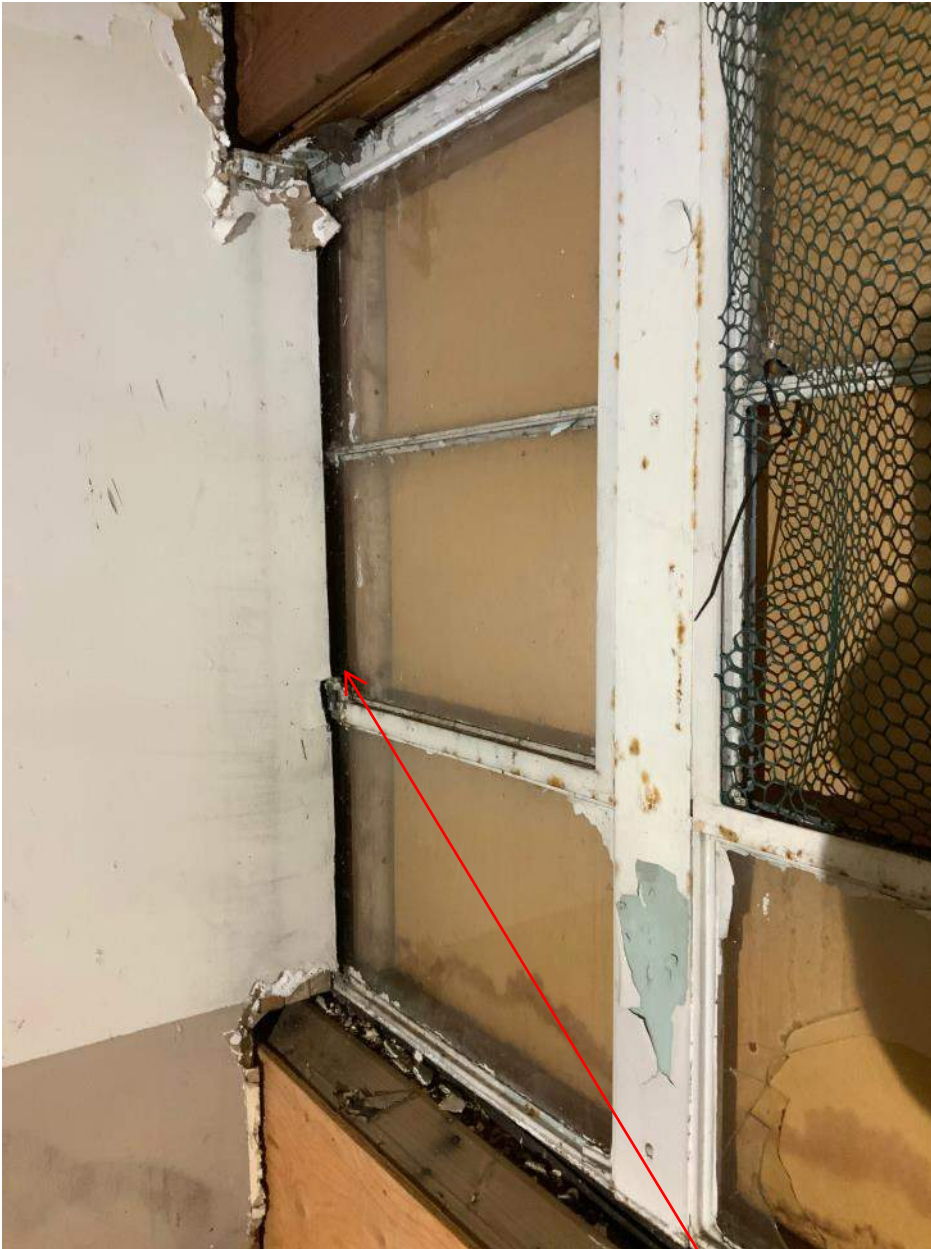
DESCRIPTION	Awning
WINDOW LOCATION	N-2-11
WINDOW CONDITION	Typical/ Fair
HARDWARE	Casement Lock/ 2 Hinges
GLASS	1/8" Clear
CRITICAL DIMENSIONS	49"X50"

Split by interior wall framing

N-2-11 is split by
interior wall framing

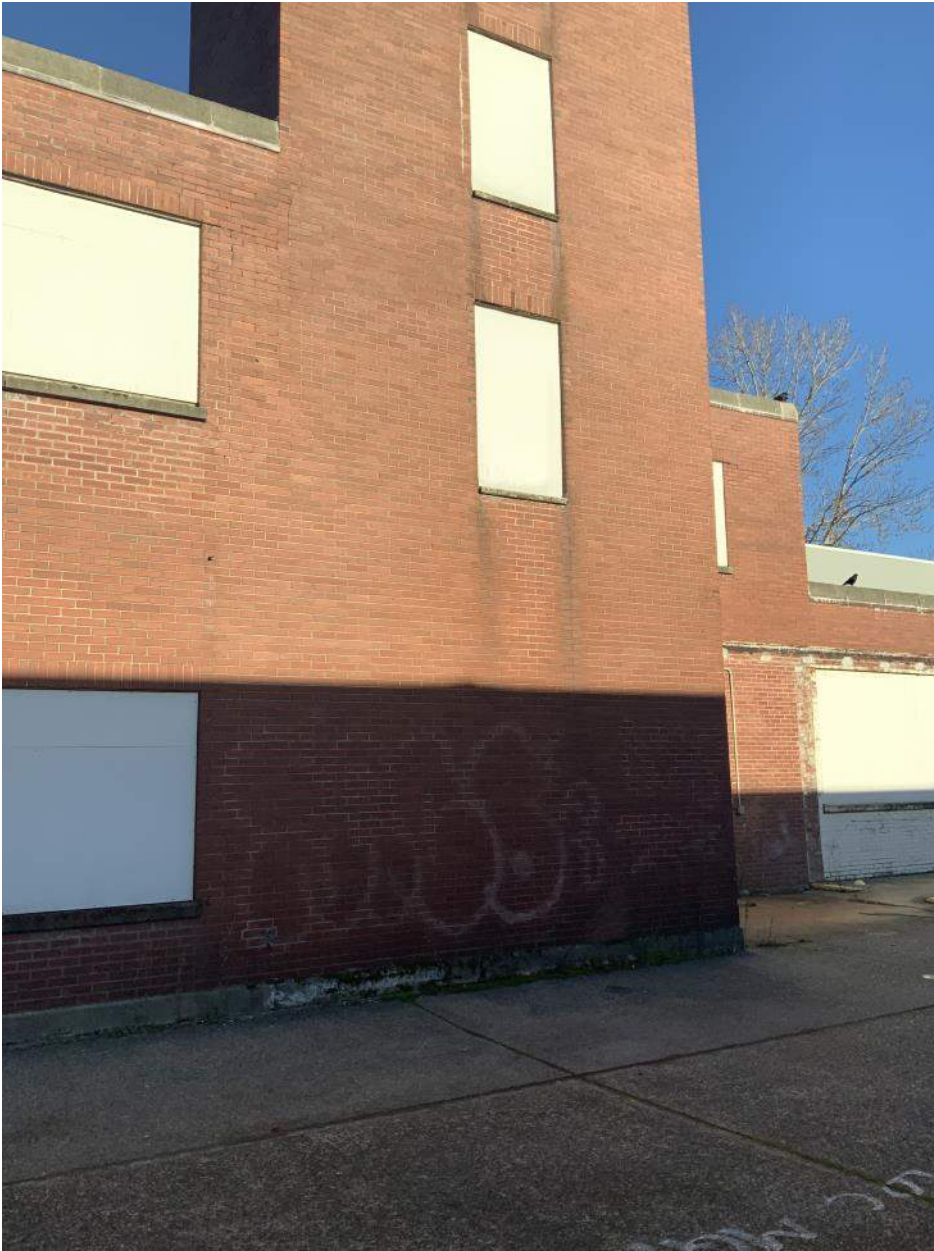
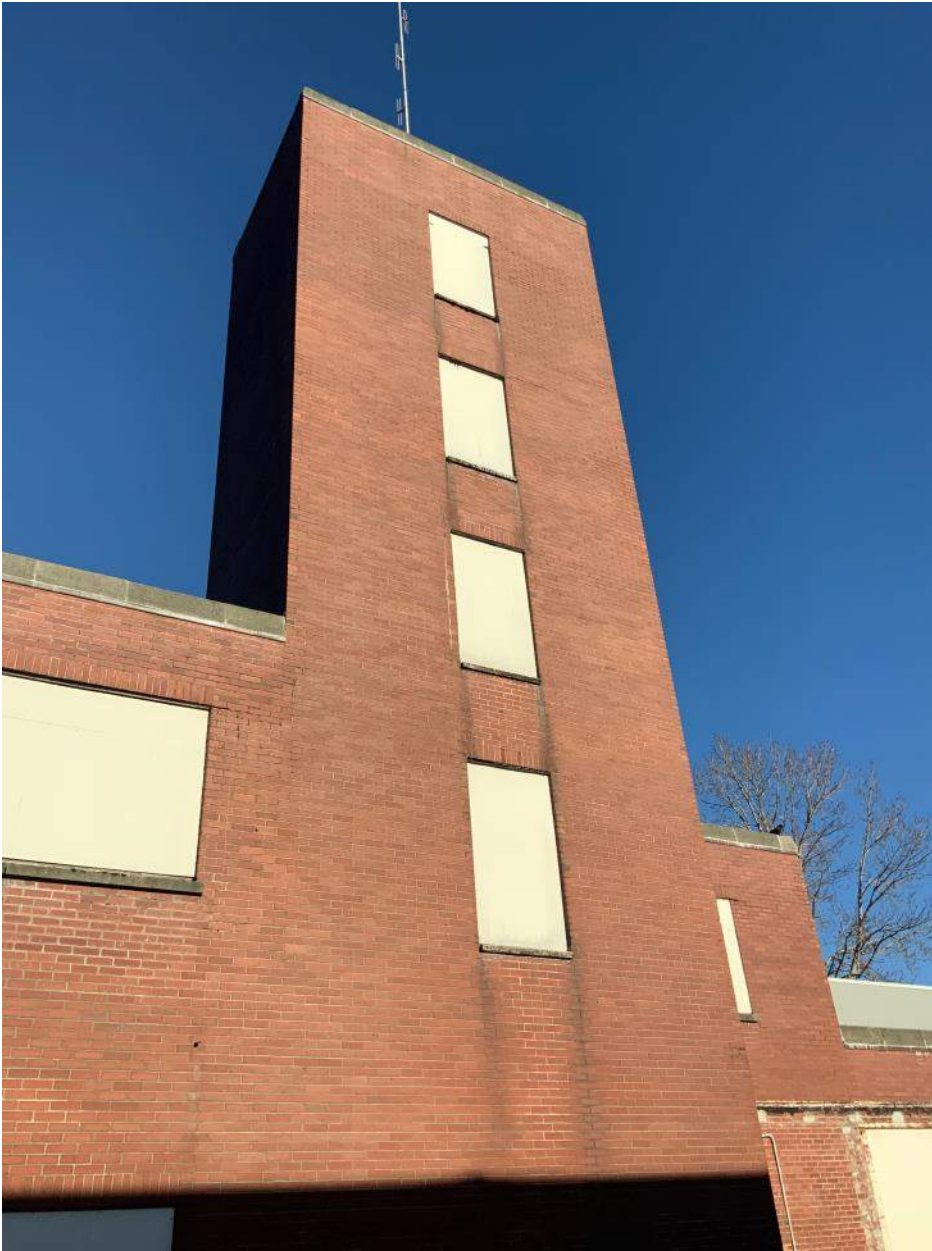
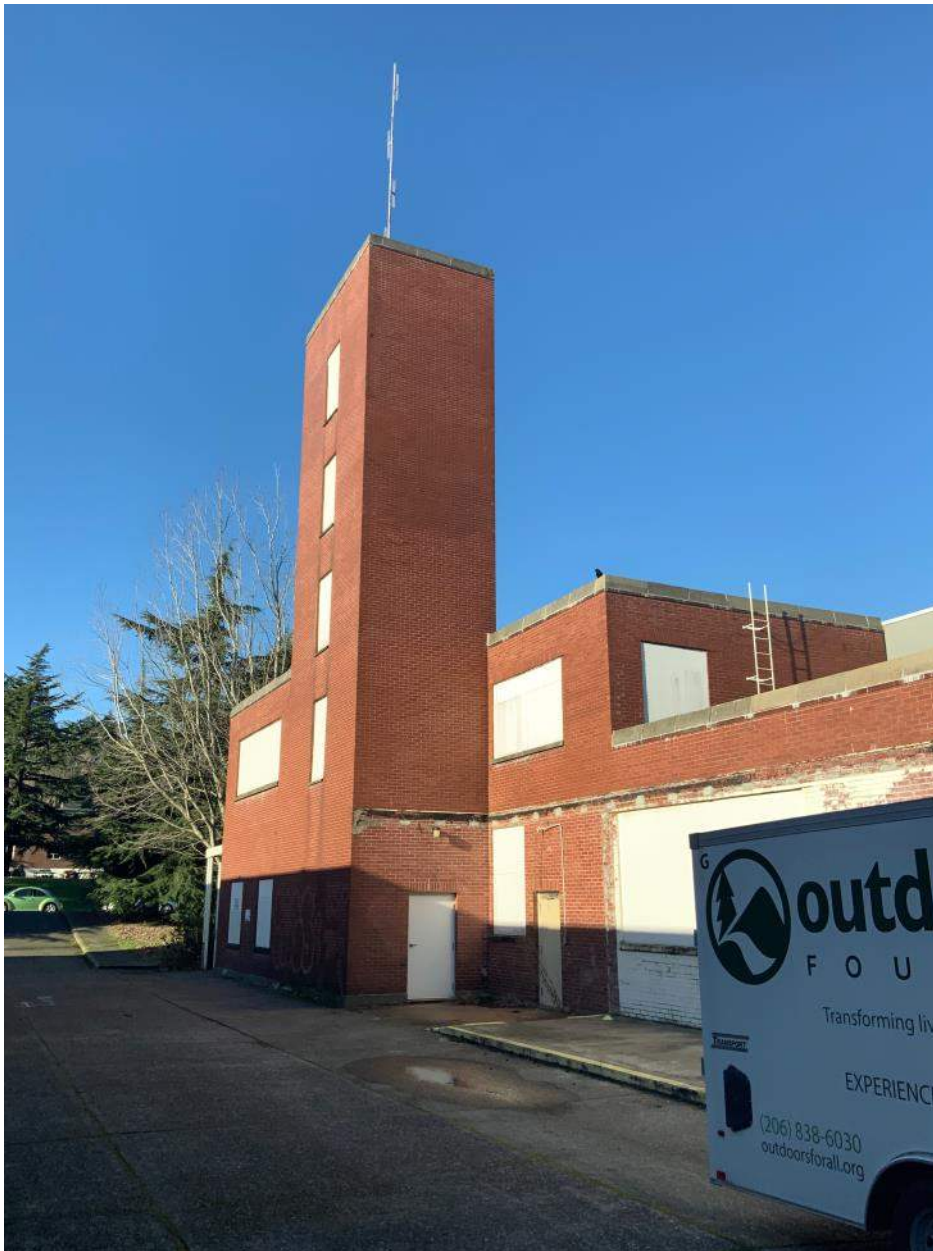
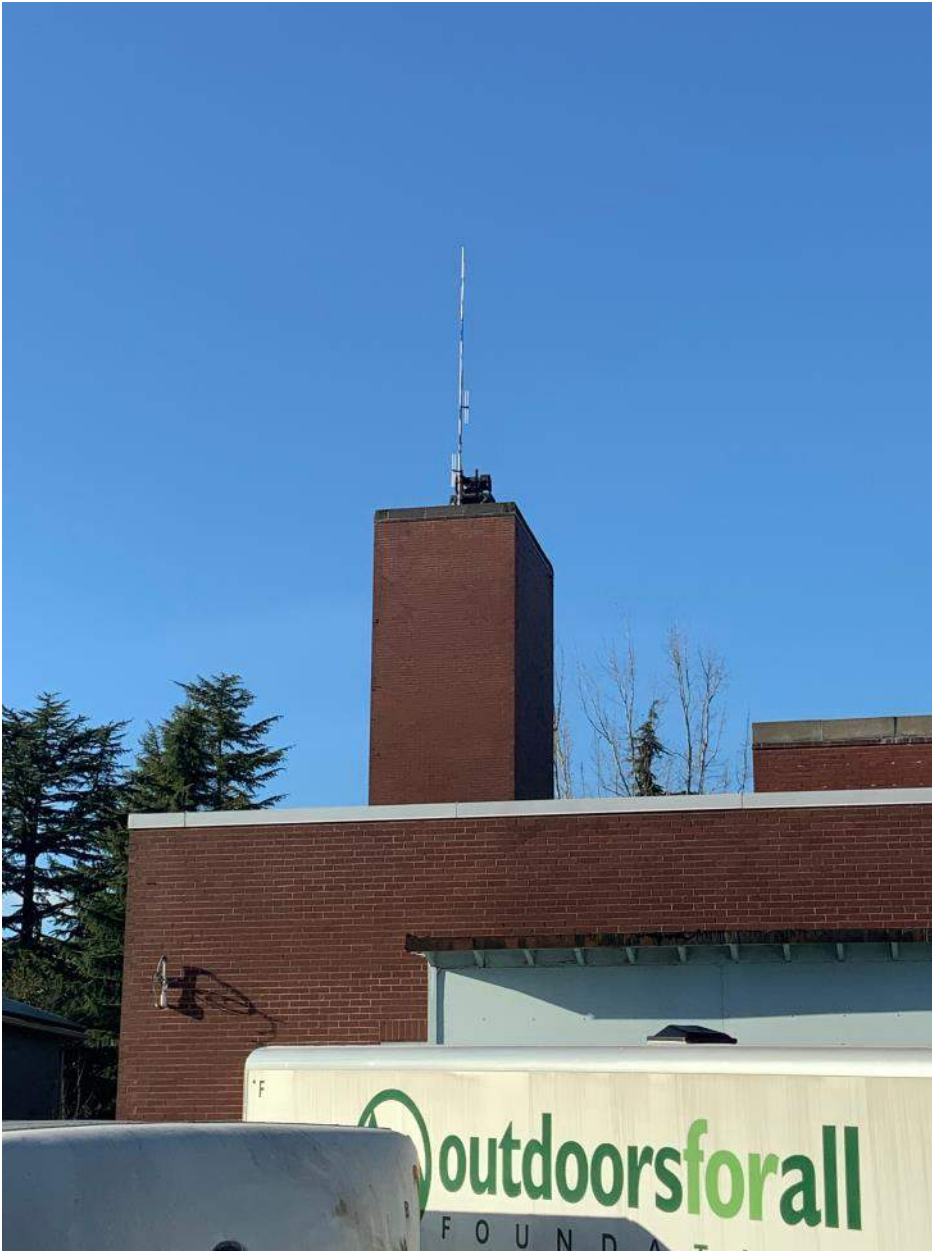
DESCRIPTION	Hose Drying Tower
WINDOW LOCATION	Hose Drying Tower
WINDOW CONDITION	
HARDWARE	
GLASS	
WEIGHTS	
TRIM	
OSB DIMENSIONS	
CRITICAL DIMENSIONS

No Existing Sash and Jambs
